Geophysical Exploration Report Highland Horizon Pool Brushy Creek Municipal Utility District

February 16, 2026

Geophysical Exploration Report Brushy Creek Municipal Utility District Williamson County, Texas

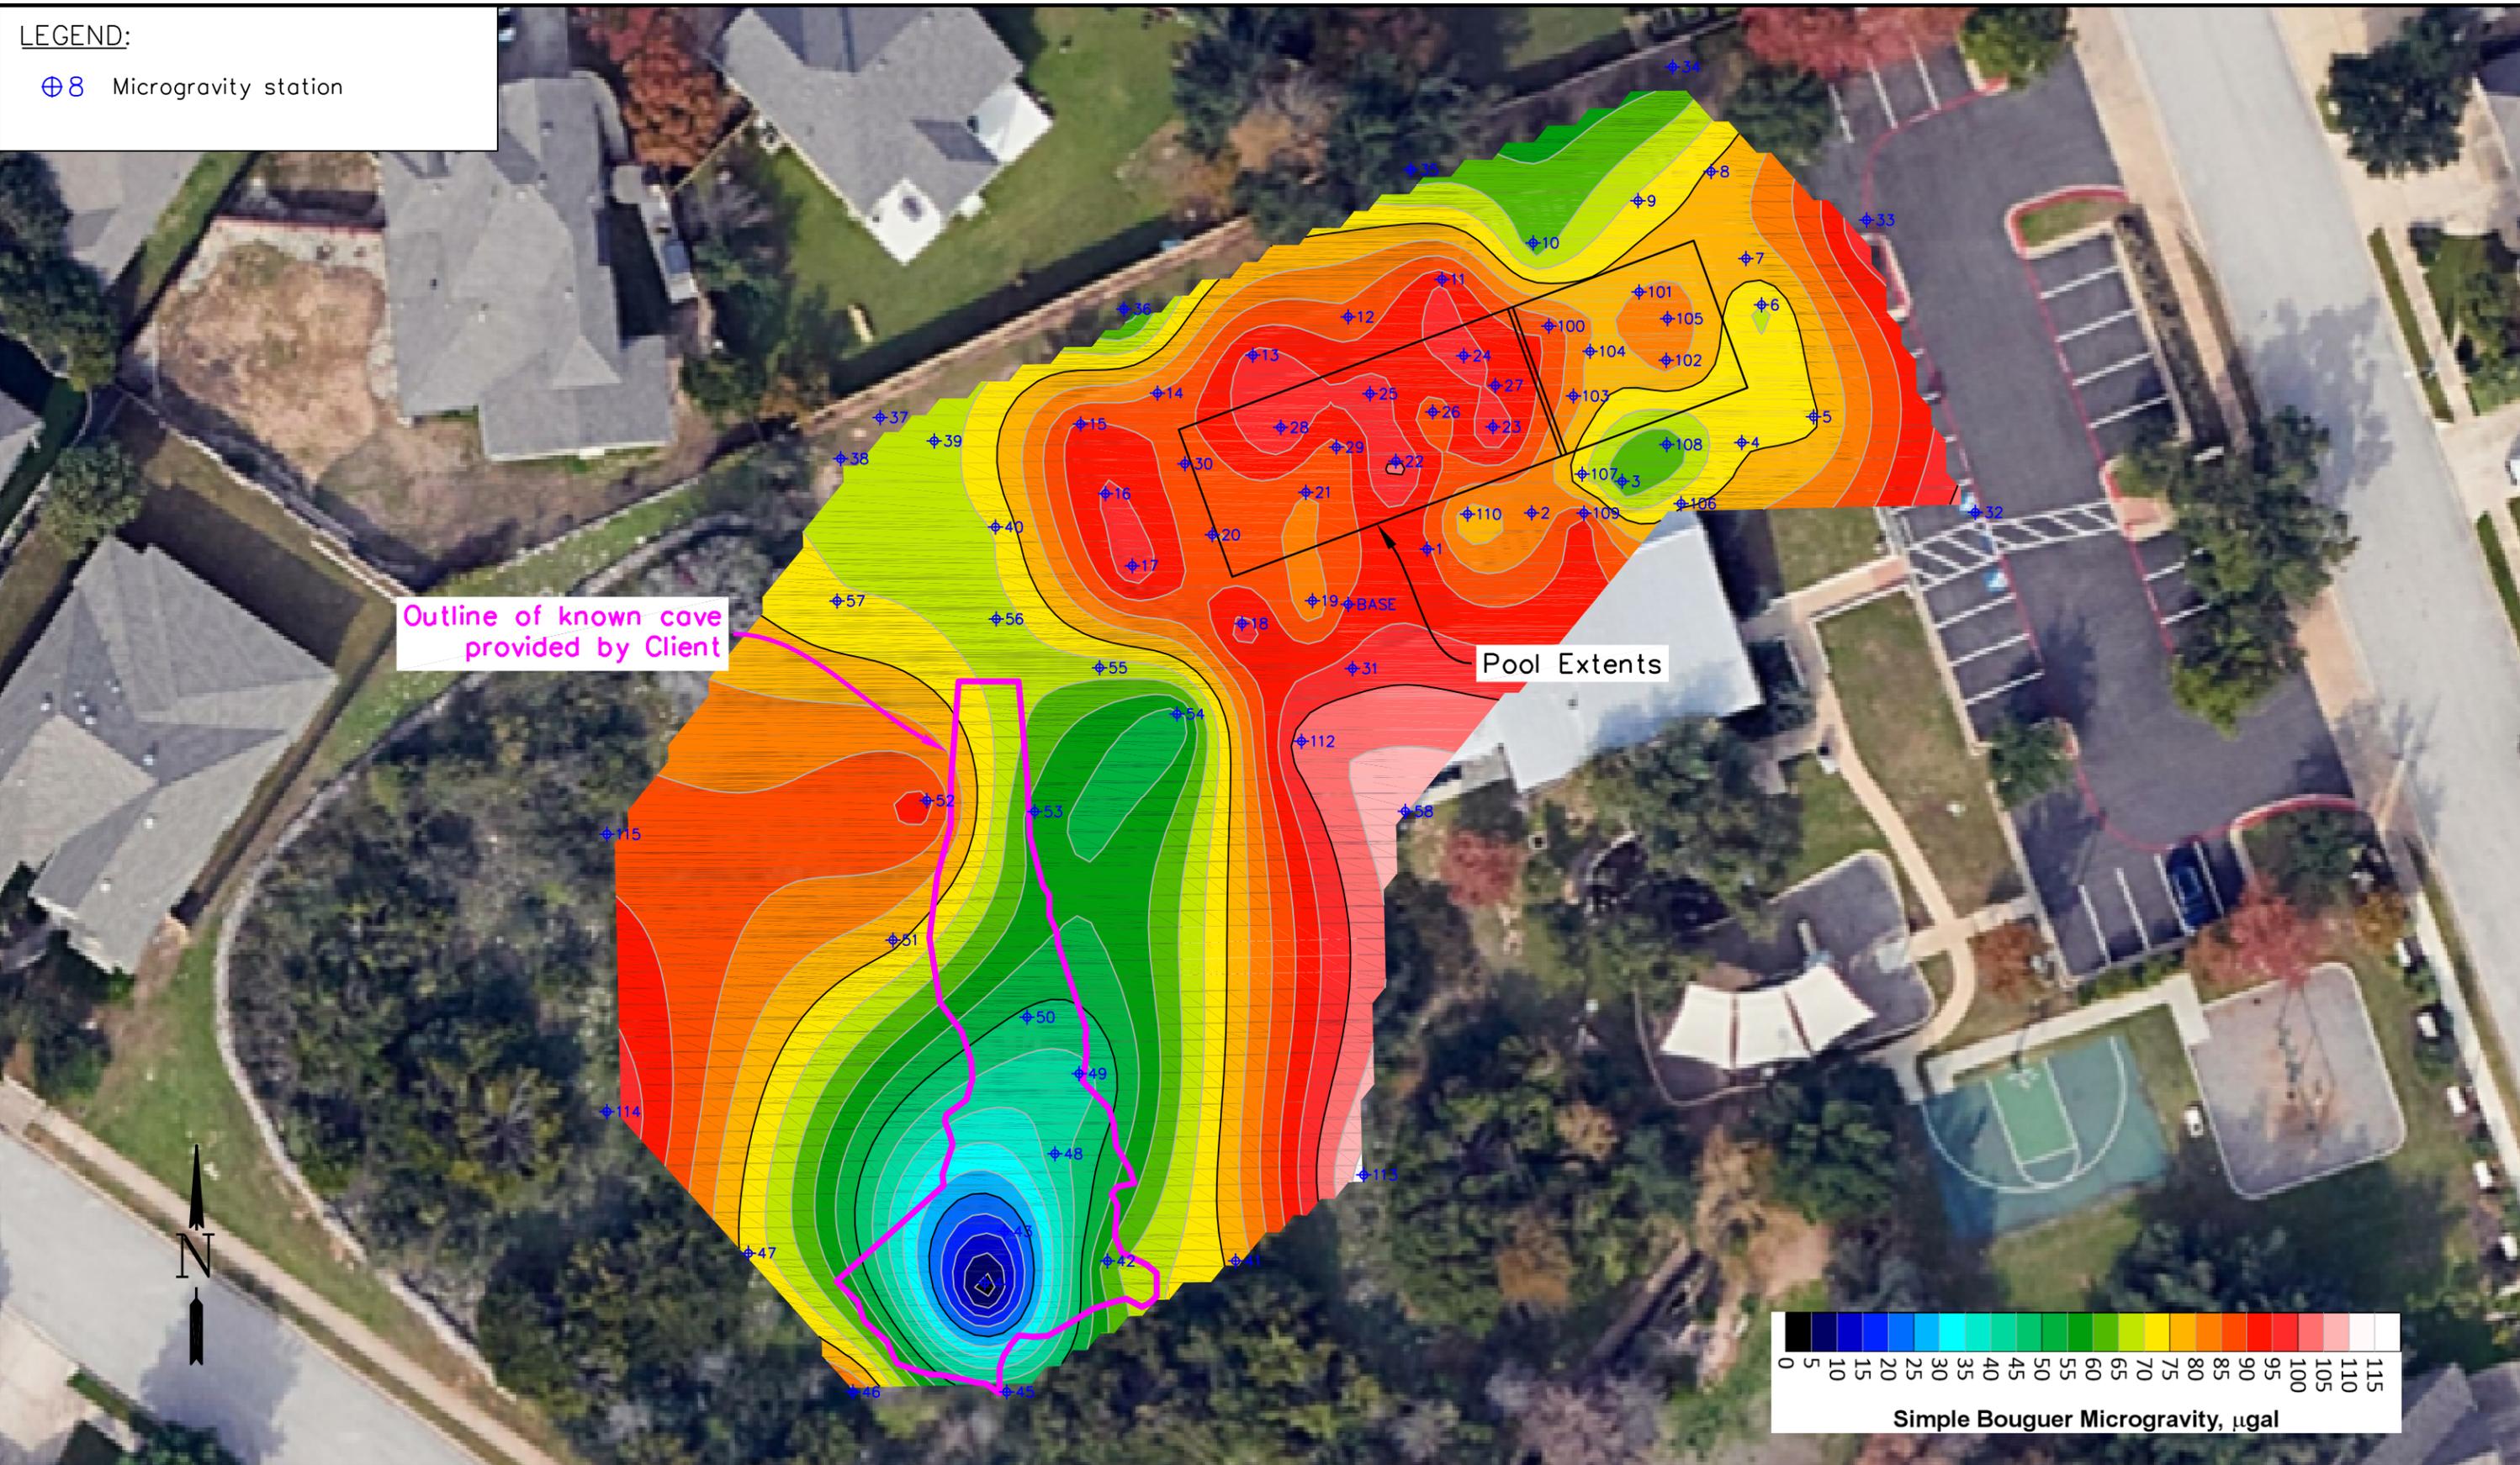
Figure No.
 1

- Figure 1 - Bouguer Microgravity Map provides a regional gravity map highlighting an overall gravity gradient trending lower towards Ensor Cave system. Higher gravity readings were typically directly below the pool shell.

BOUGUER GRAVITY

The microgravity data was processed using a Microsoft Excel spreadsheet created inhouse. Figure 1 – Bouguer Microgravity Map plots the overall site gravity of the tract after all appropriate corrections have been made. Figure 2 - Residual

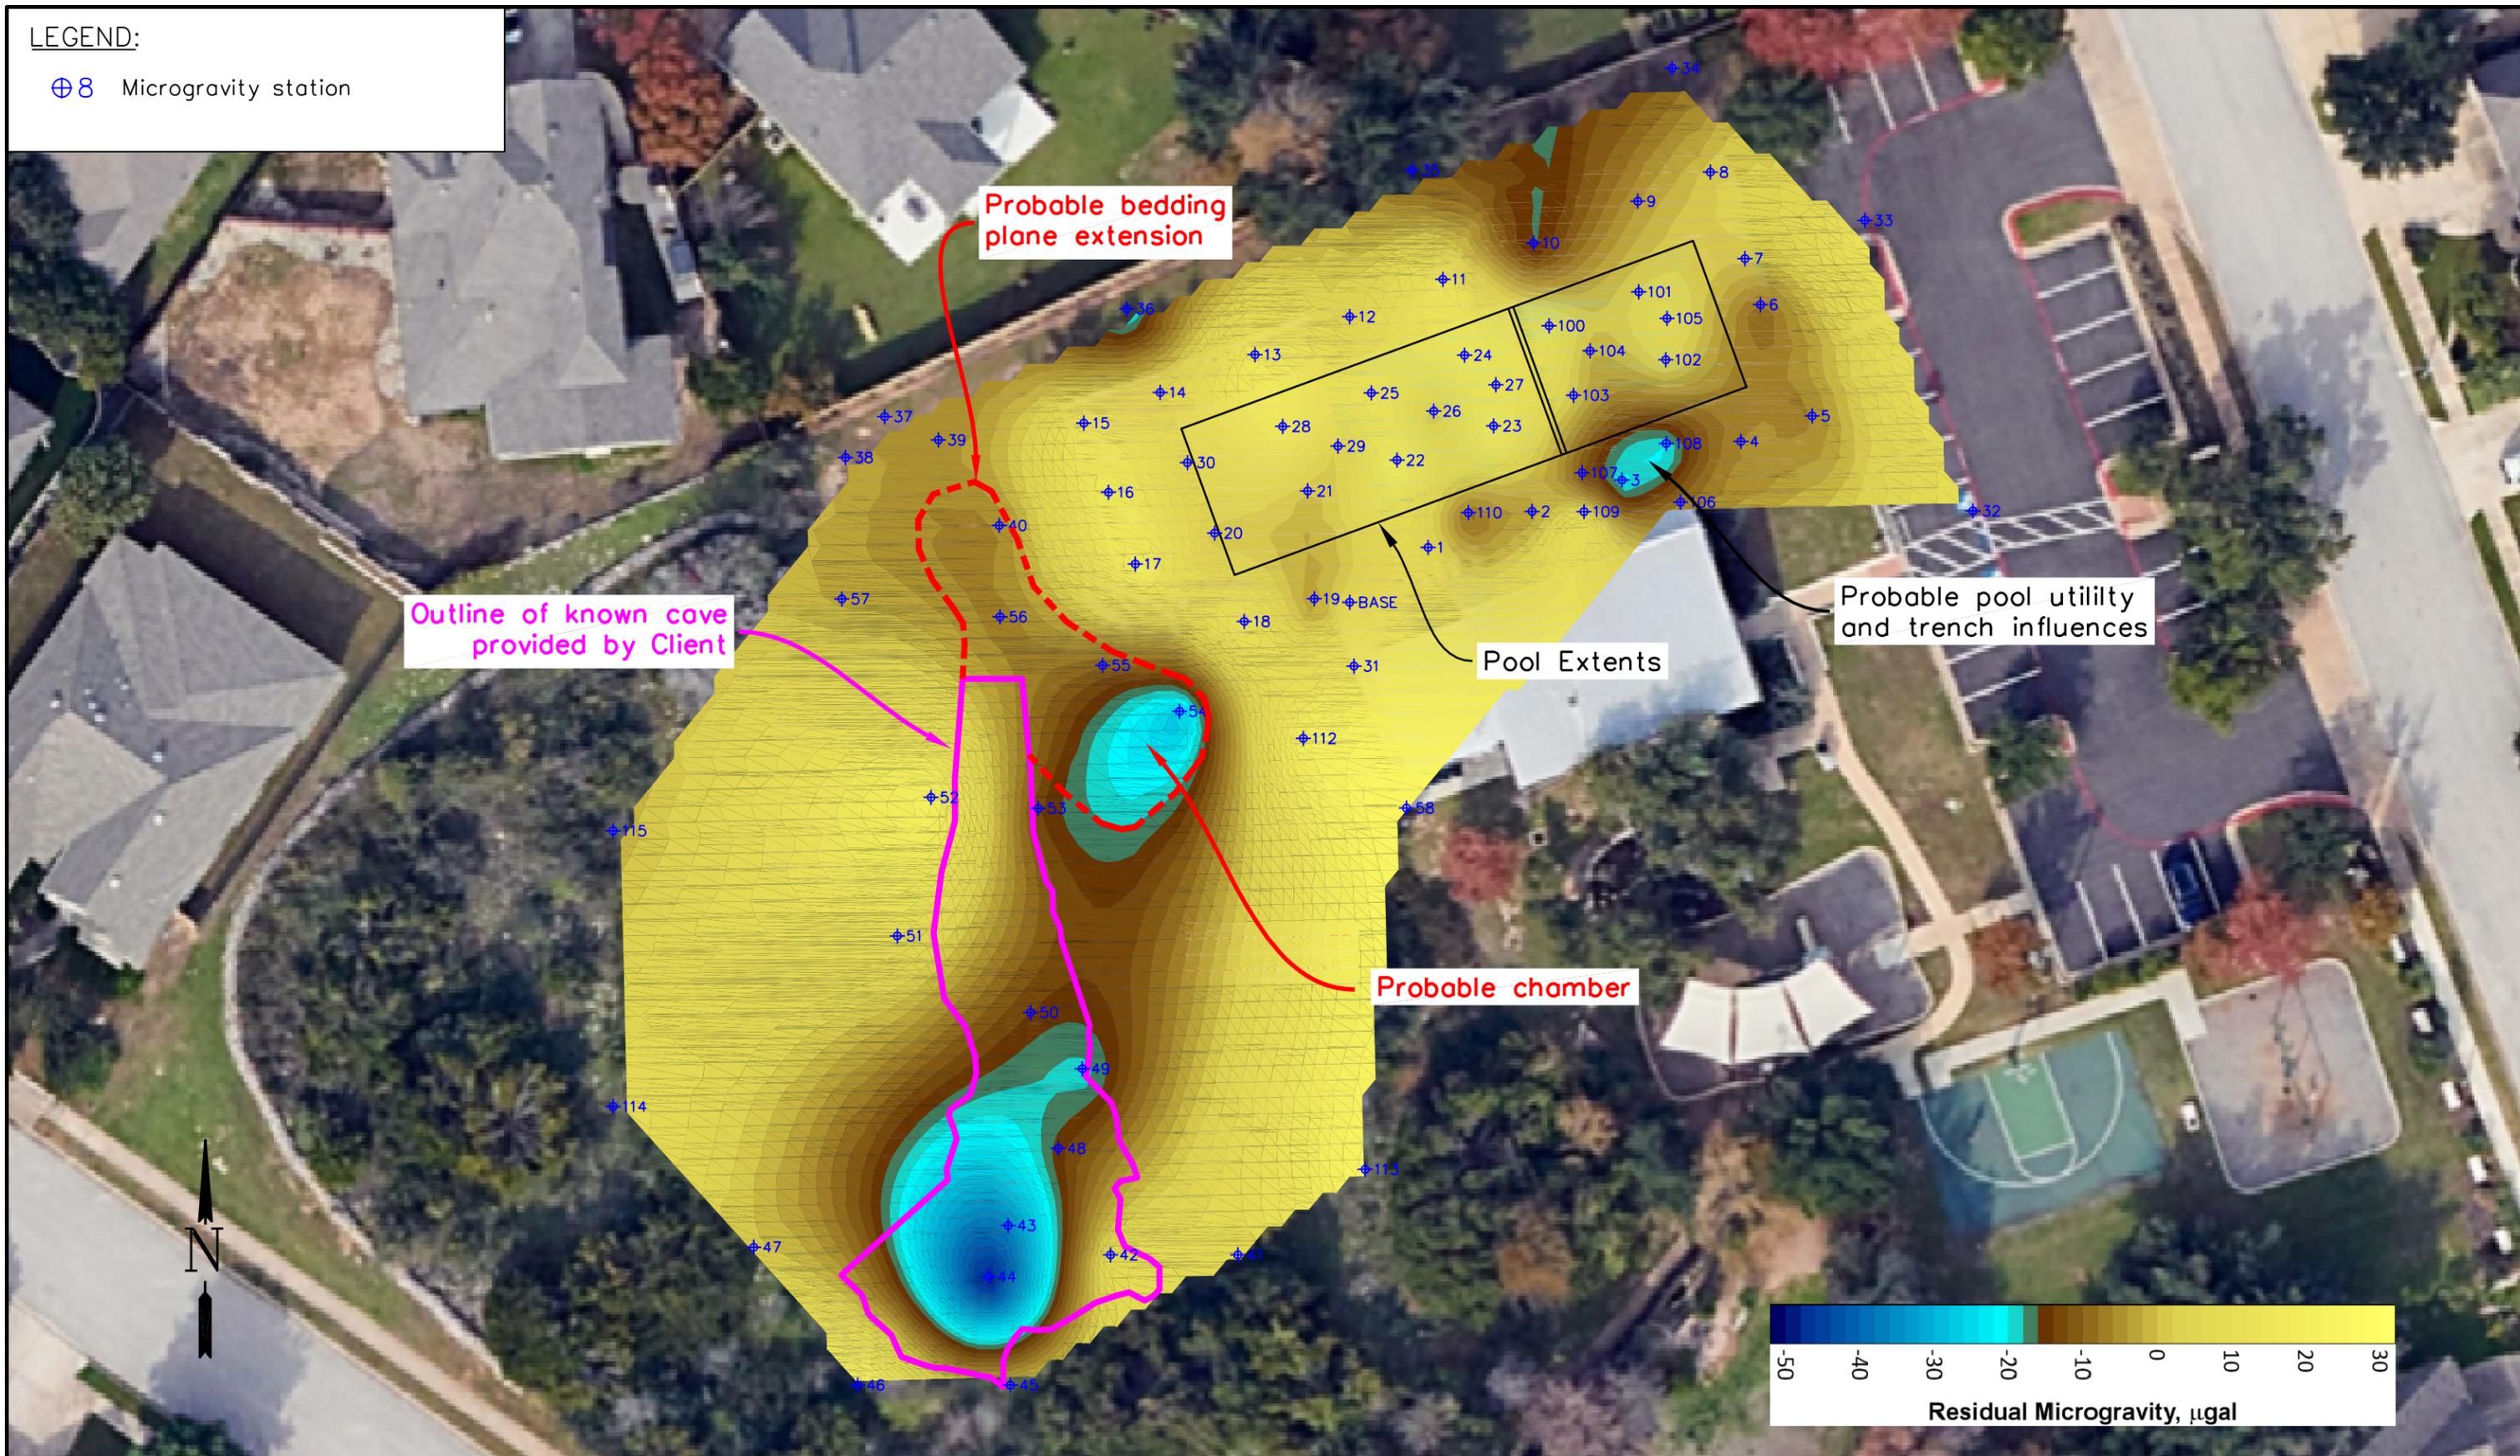
RESIDUAL GRAVITY

Figure 2 – Residual Microgravity Map plots the gravity trends of the site after polynomial trend analysis have been performed to minimize regional gravity trends. Based on Figure 2, very distinct, linear low gravity anomaly (i.e., -20 to -50 μGal) were recorded at this site. Further interpretation of the geophysical results will be discussed in Section G.

- Figure 2 plots the residual map with trend removal. Residual gravity provides a more detailed, site specific analysis of density variations across the site. Interpretation mark-ups are also included.

- Residual gravity map reasonably mapped out the Ensor cave system with some extensions from the known outline as shown in Figure 2. A distinct gravity low at station 54 suggests a previously unknown chamber is likely present east of the known cave system. Further, karstic terrain likely extending further north of the known cave system, albeit the gravity responses suggests it might be related to the bedding plane byway versus a large chamber. GPR reflectivity in the shallower rock units was high in this area as shown in Figures 8 to 10.

- Gravity data suggests that Ensor Cave system or other karstic terrain does not extend below the inground pool shells. Gravity data suggest competent, intact limestone rock is present below the pool shell with no recorded gravity lows present. Further, the GPR data did not encounter any voids directly below the pool shells. Therefore, Gehrig, Inc. is of the opinion that the karstic topography is not responsible for cracking in the pool shell.

- The remaining site encountered normal gravity variations as represented by the brown and tan color shades in Figure 2. Some gravity variations are to be expected within the upper limestone rock mass due to spatial and vertical weathering variations, small scale vugs/cavities, and limestone rock density variations.

Microgravity Map assists in the removal of long wavelength, regional trends from the data by deducting a regression trend from the data set. The final data output, which includes the regression trend removal, was gridded using the Kriging method in Surfer v.28 from Golden Software, Inc.

- A very low gravity anomaly is indicative of air-filled and/or spatially extensive large void(s). As an example, a 20 foot diameter air-filled spherical void with top of void ~10 feet below grade level would yield a theoretical response of -50 μGal . Very low gravity responses was recorded at this site near the cave entrance. This is represented by the dark blue colors

- A low gravity anomaly can be indicative of a smaller air filled void, less dense soils, high fractured network, and/or infilled karst terrain. This is represented by the light blue colors in Figure 2, possibly extending into the dark brown areas. As an example, a 14 foot diameter, spherical air-filled void with top of void ~10 feet below grade level would yield a theoretical response of -25 μGal .

- A near zero μGal background or positive gravity measurement is typically indicative of more intact dense soil/rock with minimal or no karst development. This is represented by the tan to brown colors in Figure 2.

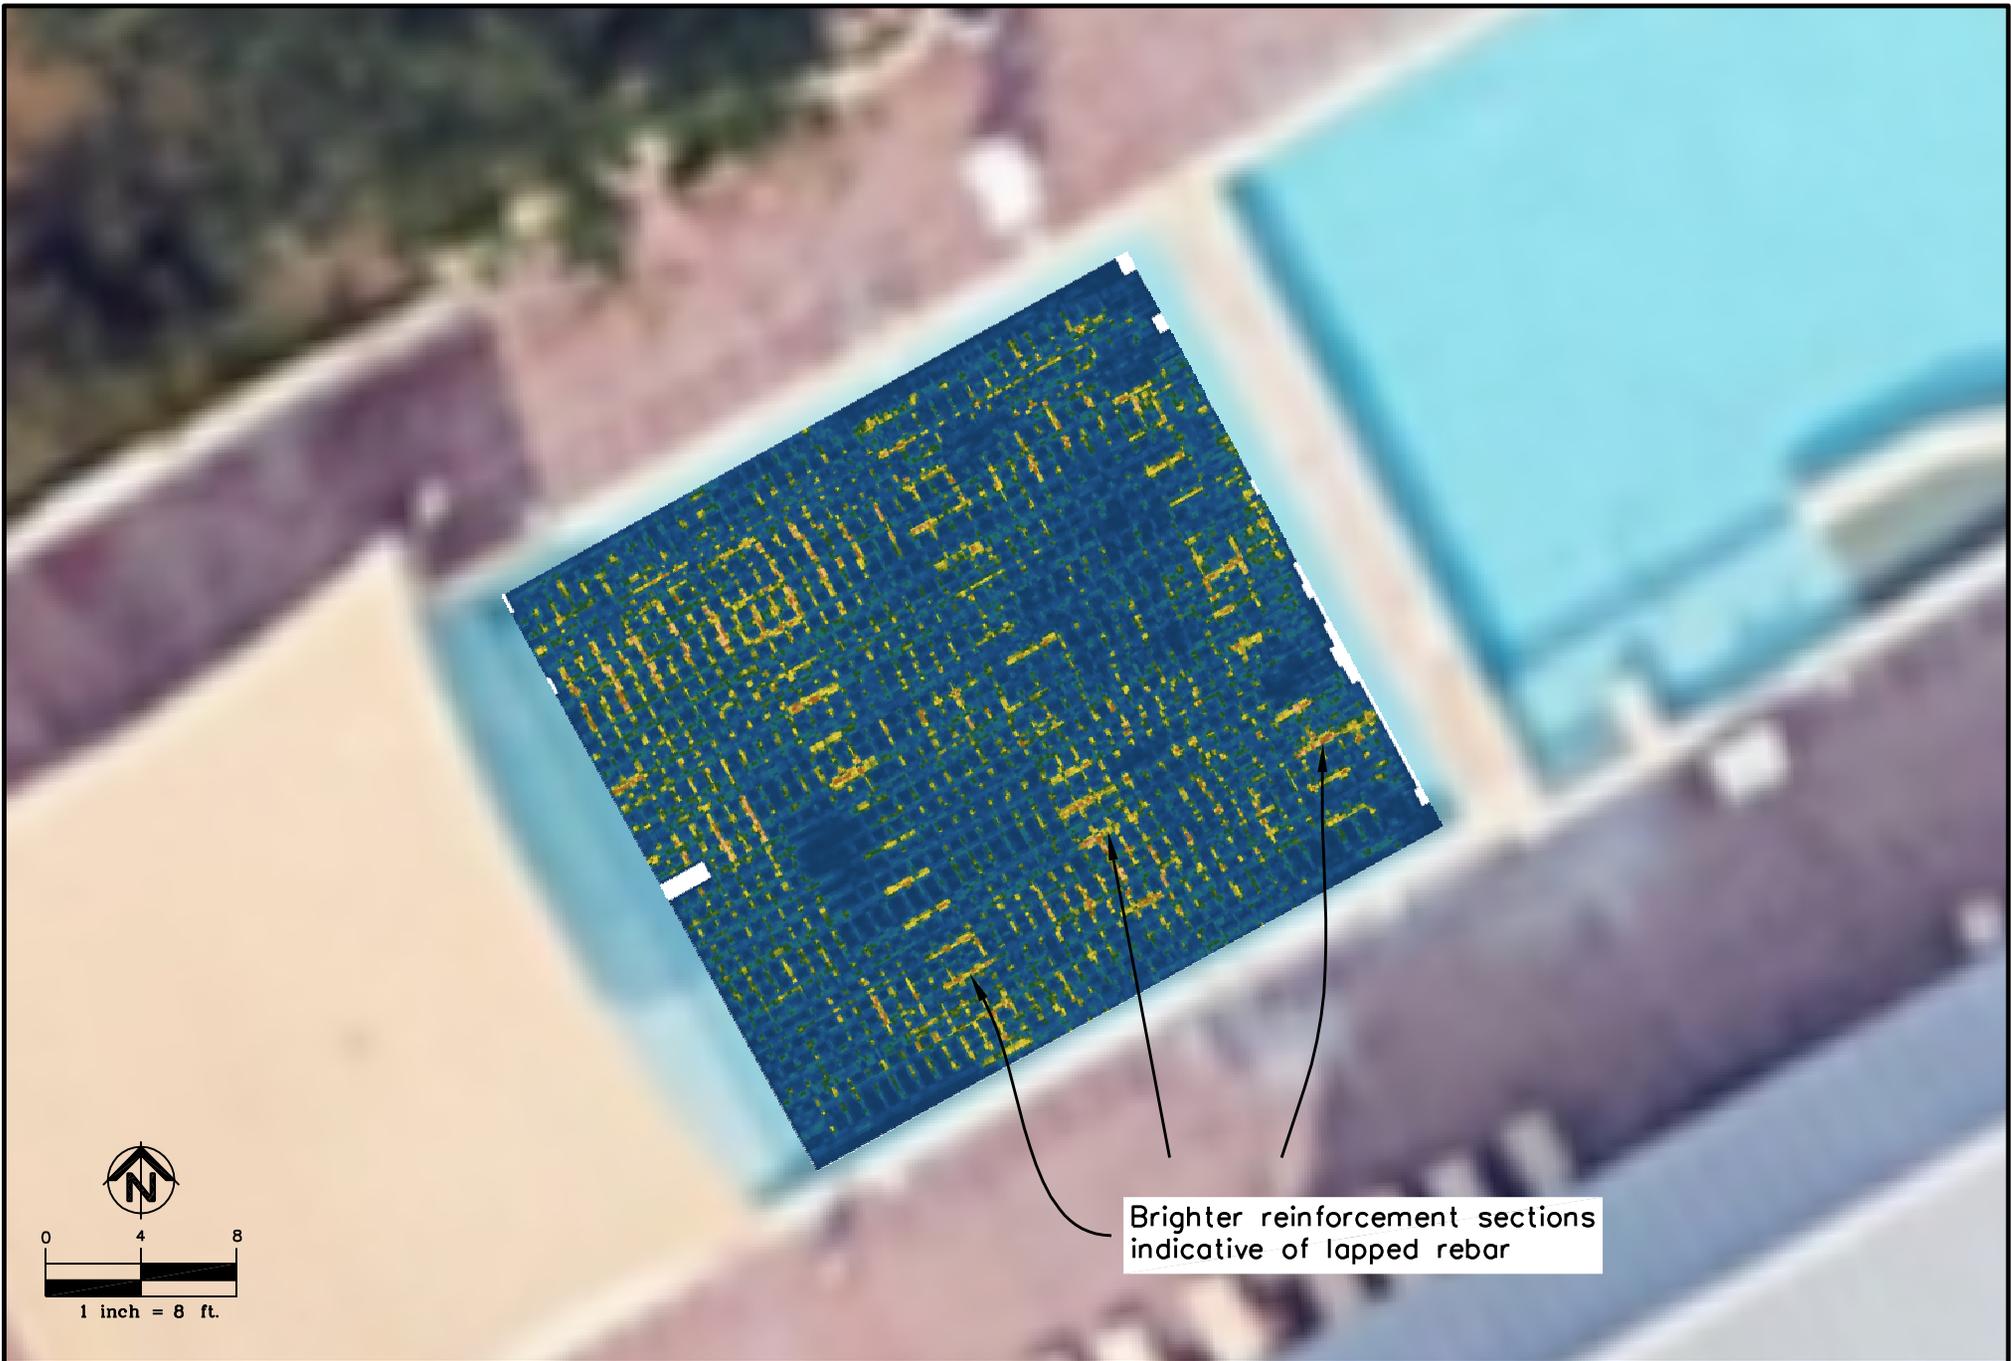
Figure
 No.
 3

Brighter reinforcement sections
indicative of lapped rebar

HiRes GPR Horizontal Depth Slice - 6 inches
 Highland Horizon Pool - West Pool
 Austin, TX 78717

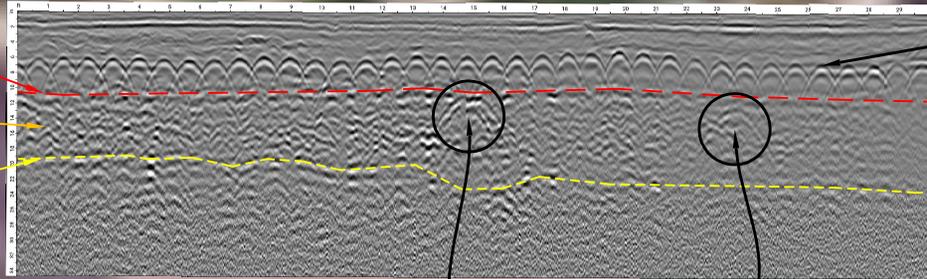
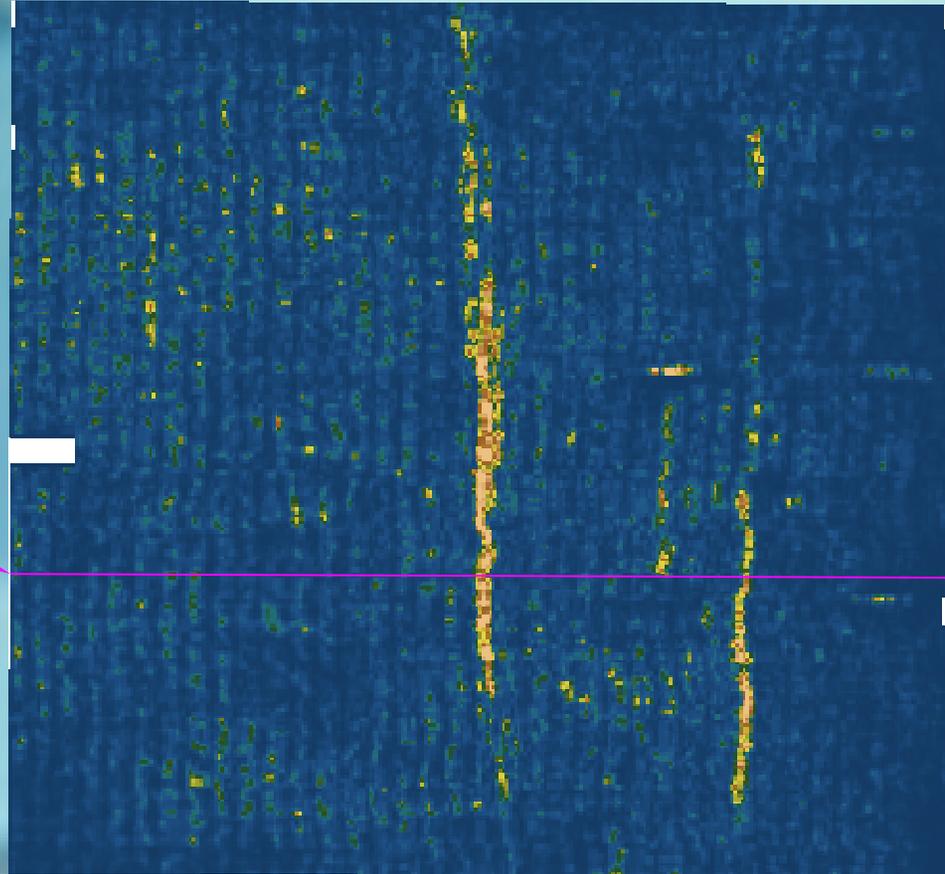
4

2D Profile

Bottom of concrete layer

Sub-base layer

Potential top of native rock

Reinforcement spaced approx. 10" O.C.

Reflections indicative of subsurface utilities

Location of 2D profile seen above

HiRes GPR Vertical Slice Example: West Pool

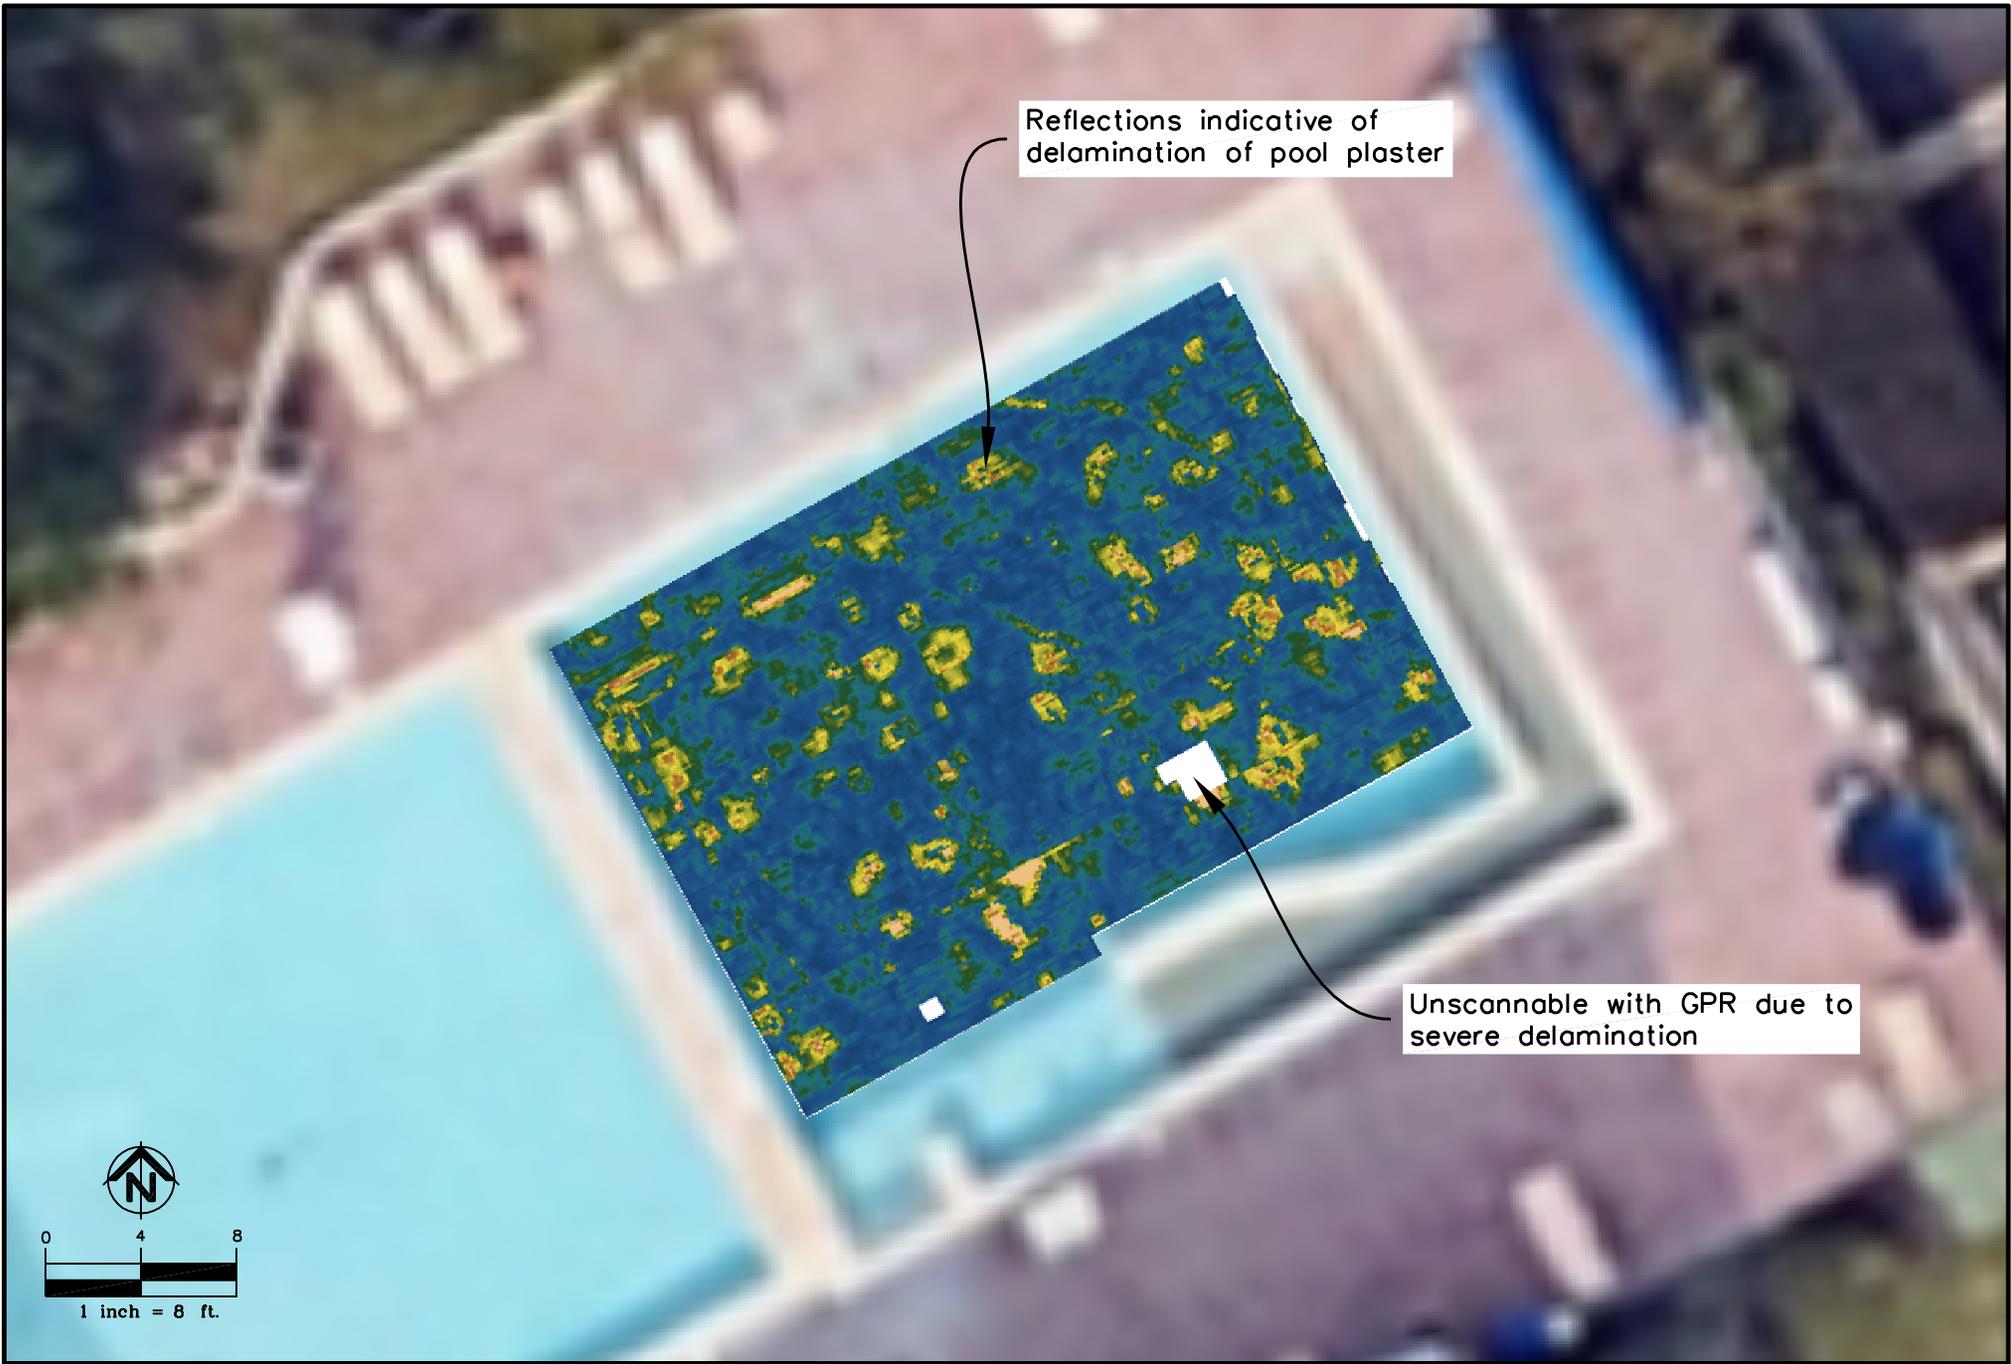
Figure No.
 5

Reflections indicative of delamination of pool plaster

Unscannable with GPR due to severe delamination

HiRes GPR Horizontal Depth Slice - 1 inch
 Highland Horizon Pool - East Pool
 Austin, TX 78717

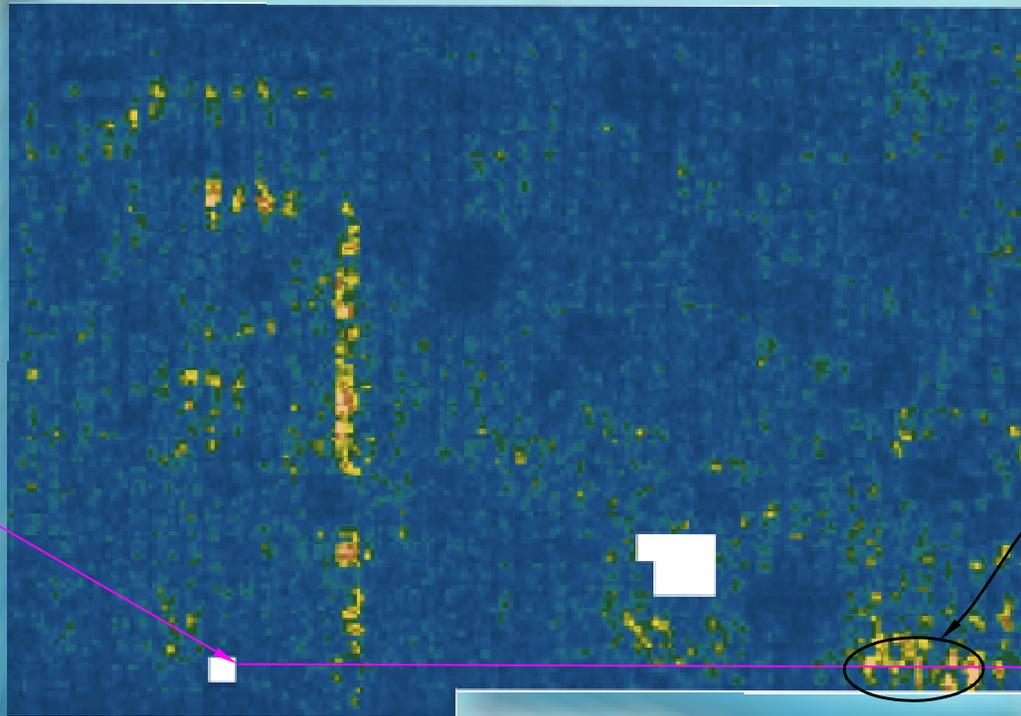
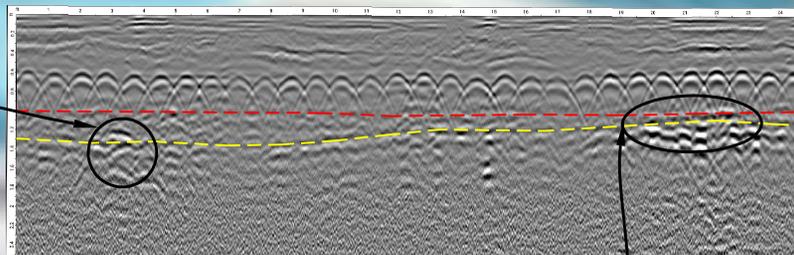
6

Stronger GPR reflections from top of rock directly beneath the slab

Reflection indicative of subsurface utility

Bottom of concrete layer

Top of native rock

Distance from bottom of slab to top of rock <1"

HiRes GPR Vertical Slice Example: East Pool

Resistance to shrinking (RTS) cracking is a well-recognized issue in structural engineering community, especially where shallow bedrock is present. When a concrete foundation, such as a gunite pool shell in this case, is partly supported by solid limestone and partly by a sand subbase, shrinkage cracks can develop. It's likely that the dividing wall between the two pool shells rests directly on limestone, while the shells themselves are supported by a subbase. Except for the southeast corner of the east pool shell, ground penetrating radar (GPR) indicated the presence of a subbase beneath the pool shell. This arrangement allows the dividing wall to remain stable, but the pool shells may 'float' on the subbase, leading to internal tensile stresses and shrinkage cracks. Notably, the cracks did not show vertical displacement, which is characteristic of shrinkage cracking rather than cracks caused by differential settlement. Additionally, the cracks appeared at nearly equal distances from both sides of the wall, further supporting the RTS cracking explanation.

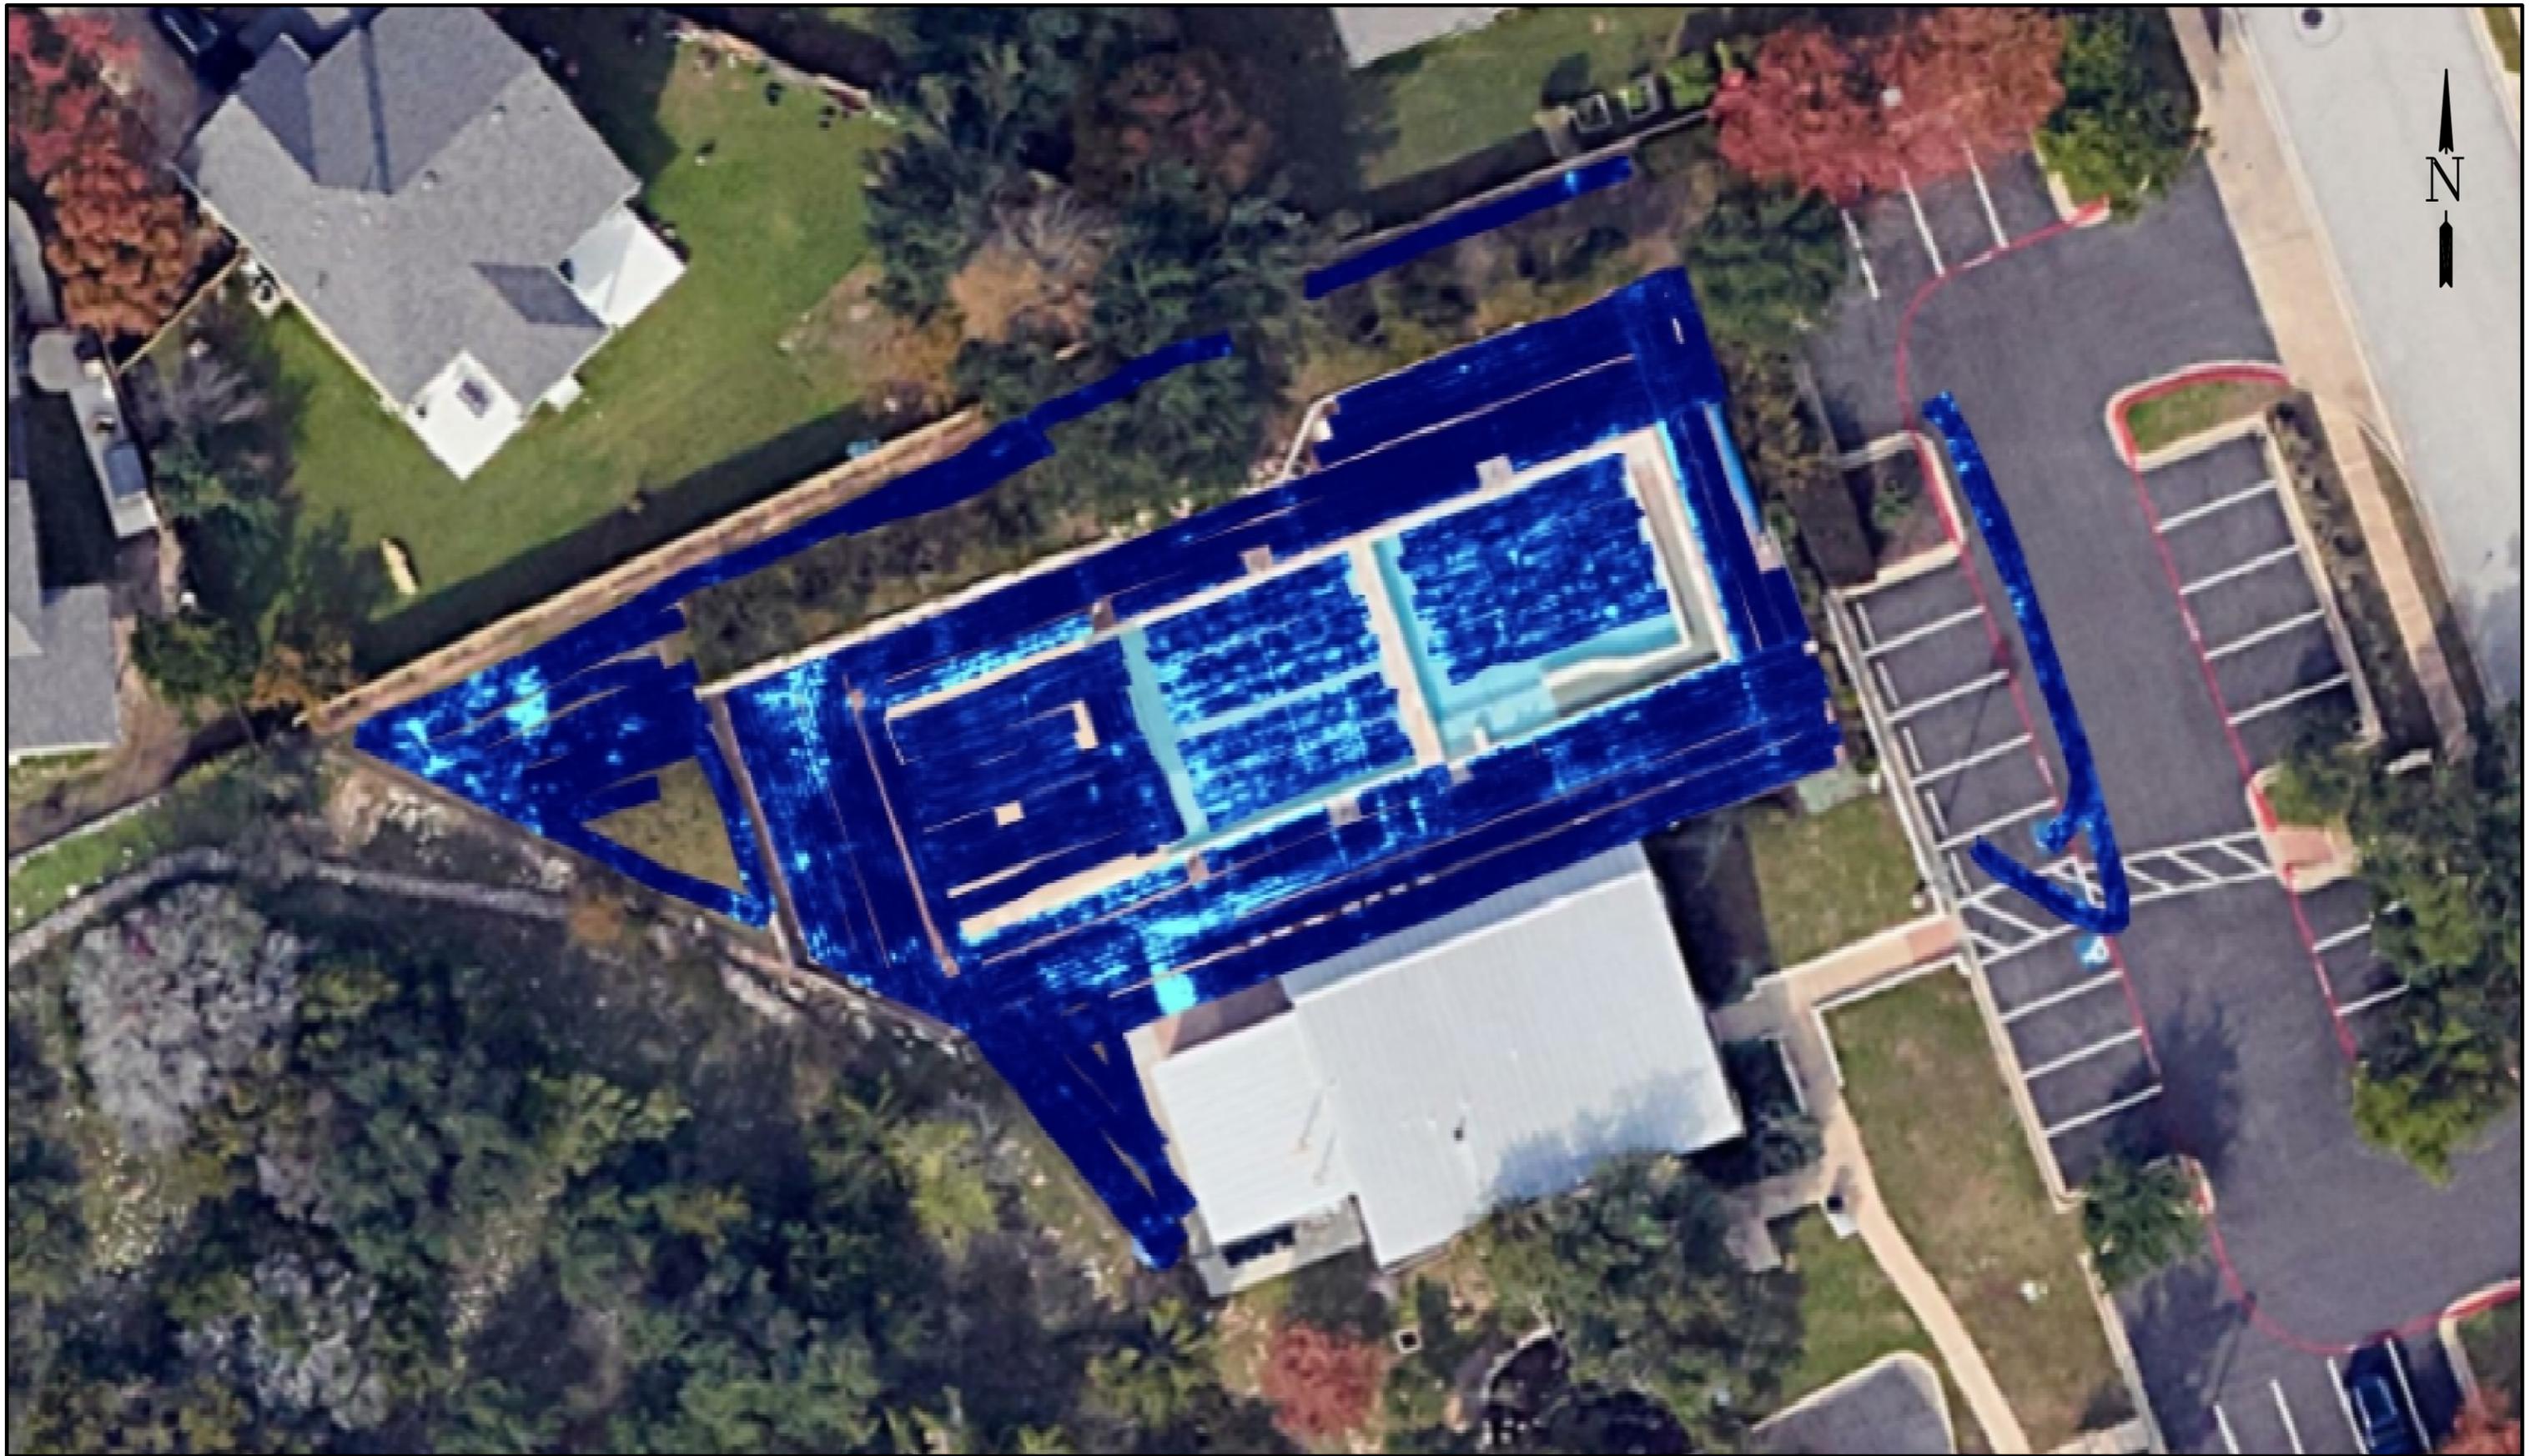
Figure No.
 7

GPR - 2ft. Depth Slice
 Highland Horizon Pool
 Austin, Texas 78717
 Project #: 26-10-006
 Survey Date: February 3-4, 2026

- HiRes GPR data over the pool shell did not encounter any voids directly below the gunite pool shell. Further, deeper penetrations from the 3D GS9000 unit did not record any anomalous reflectivity signal that could be attributed to karstic terrain.
