Geophysical Exploration Report Highland Horizon Pool Brushy Creek Municipal Utility District

February 16, 2026

Geophysical Exploration Report Brushy Creek Municipal Utility District Williamson County, Texas

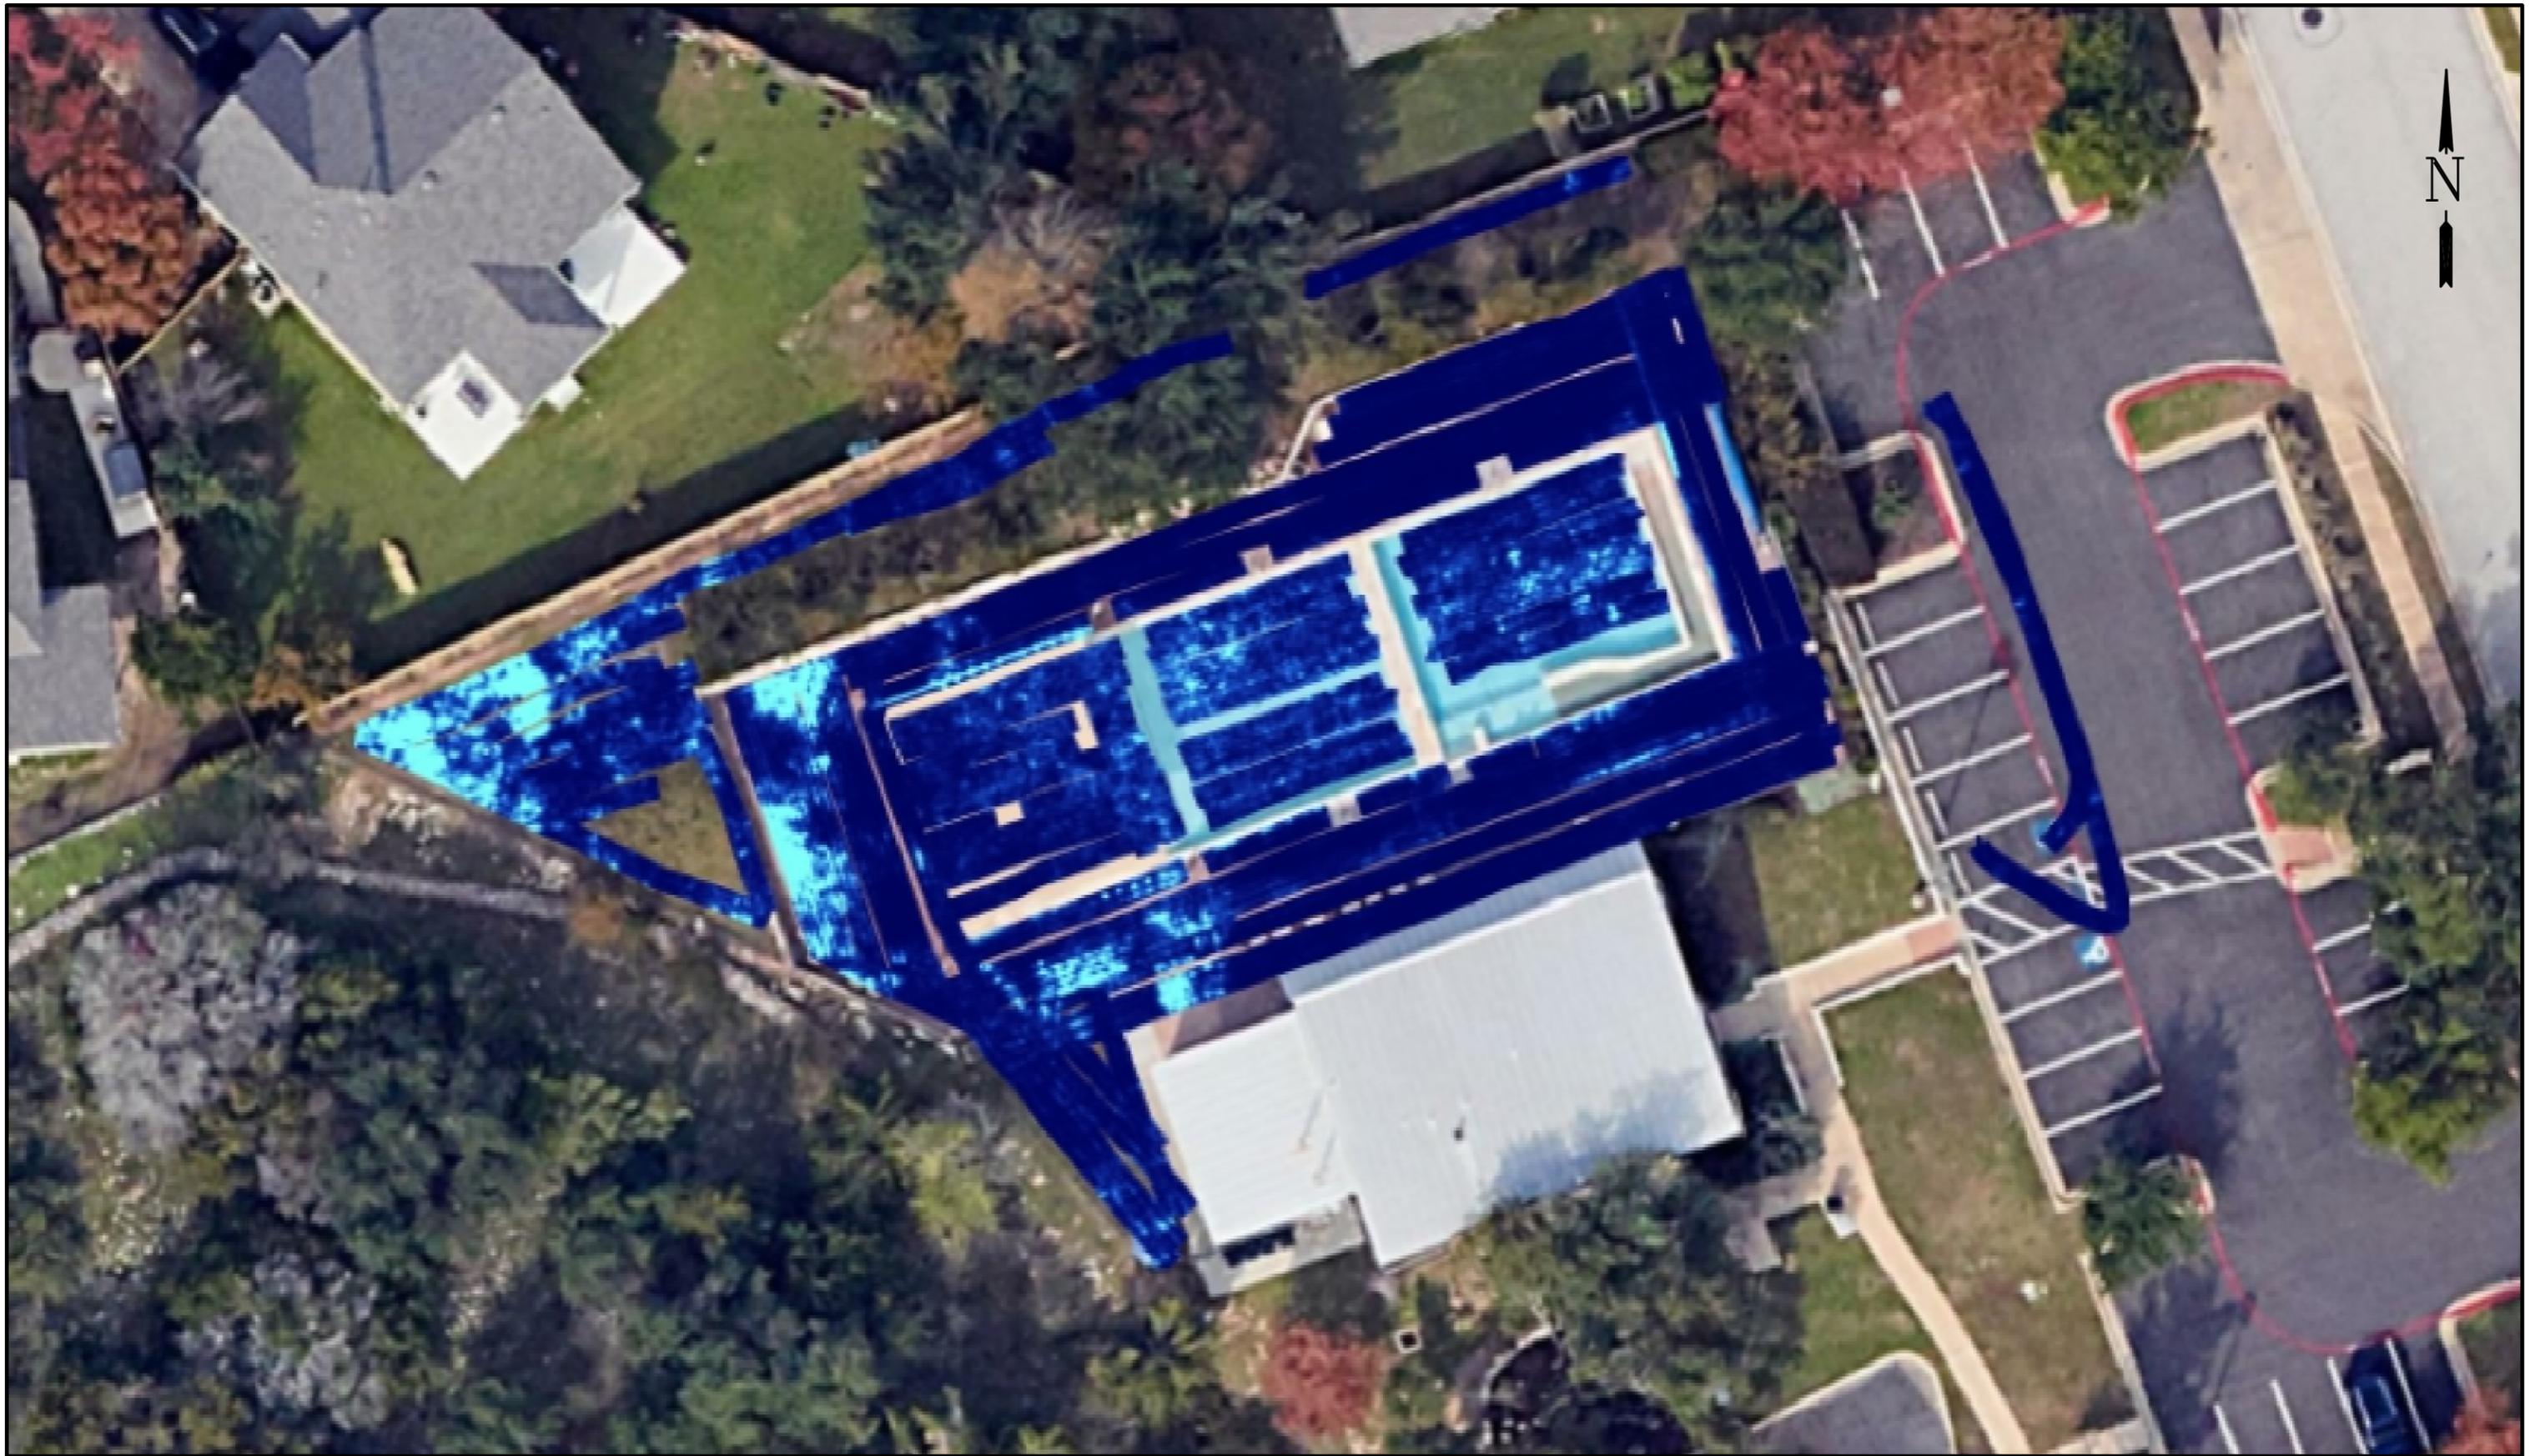
Figure No.
 8

GPR - 4ft. Depth Slice
 Highland Horizon Pool
 Austin, Texas 78717
 Project #: 26-10-006
 Survey Date: February 3-4, 2026

- Residual gravity map reasonably mapped out the Ensor cave system with some extensions from the known outline as shown in Figure 2. A distinct gravity low at station 54 suggests a previously unknown chamber is likely present east of the known cave system. Further, karstic terrain likely extending further north of the known cave system, albeit the gravity responses suggests it might be related to the bedding plane byway versus a large chamber. GPR reflectivity in the shallower rock units was high in this area as shown in Figures 8 to 10.

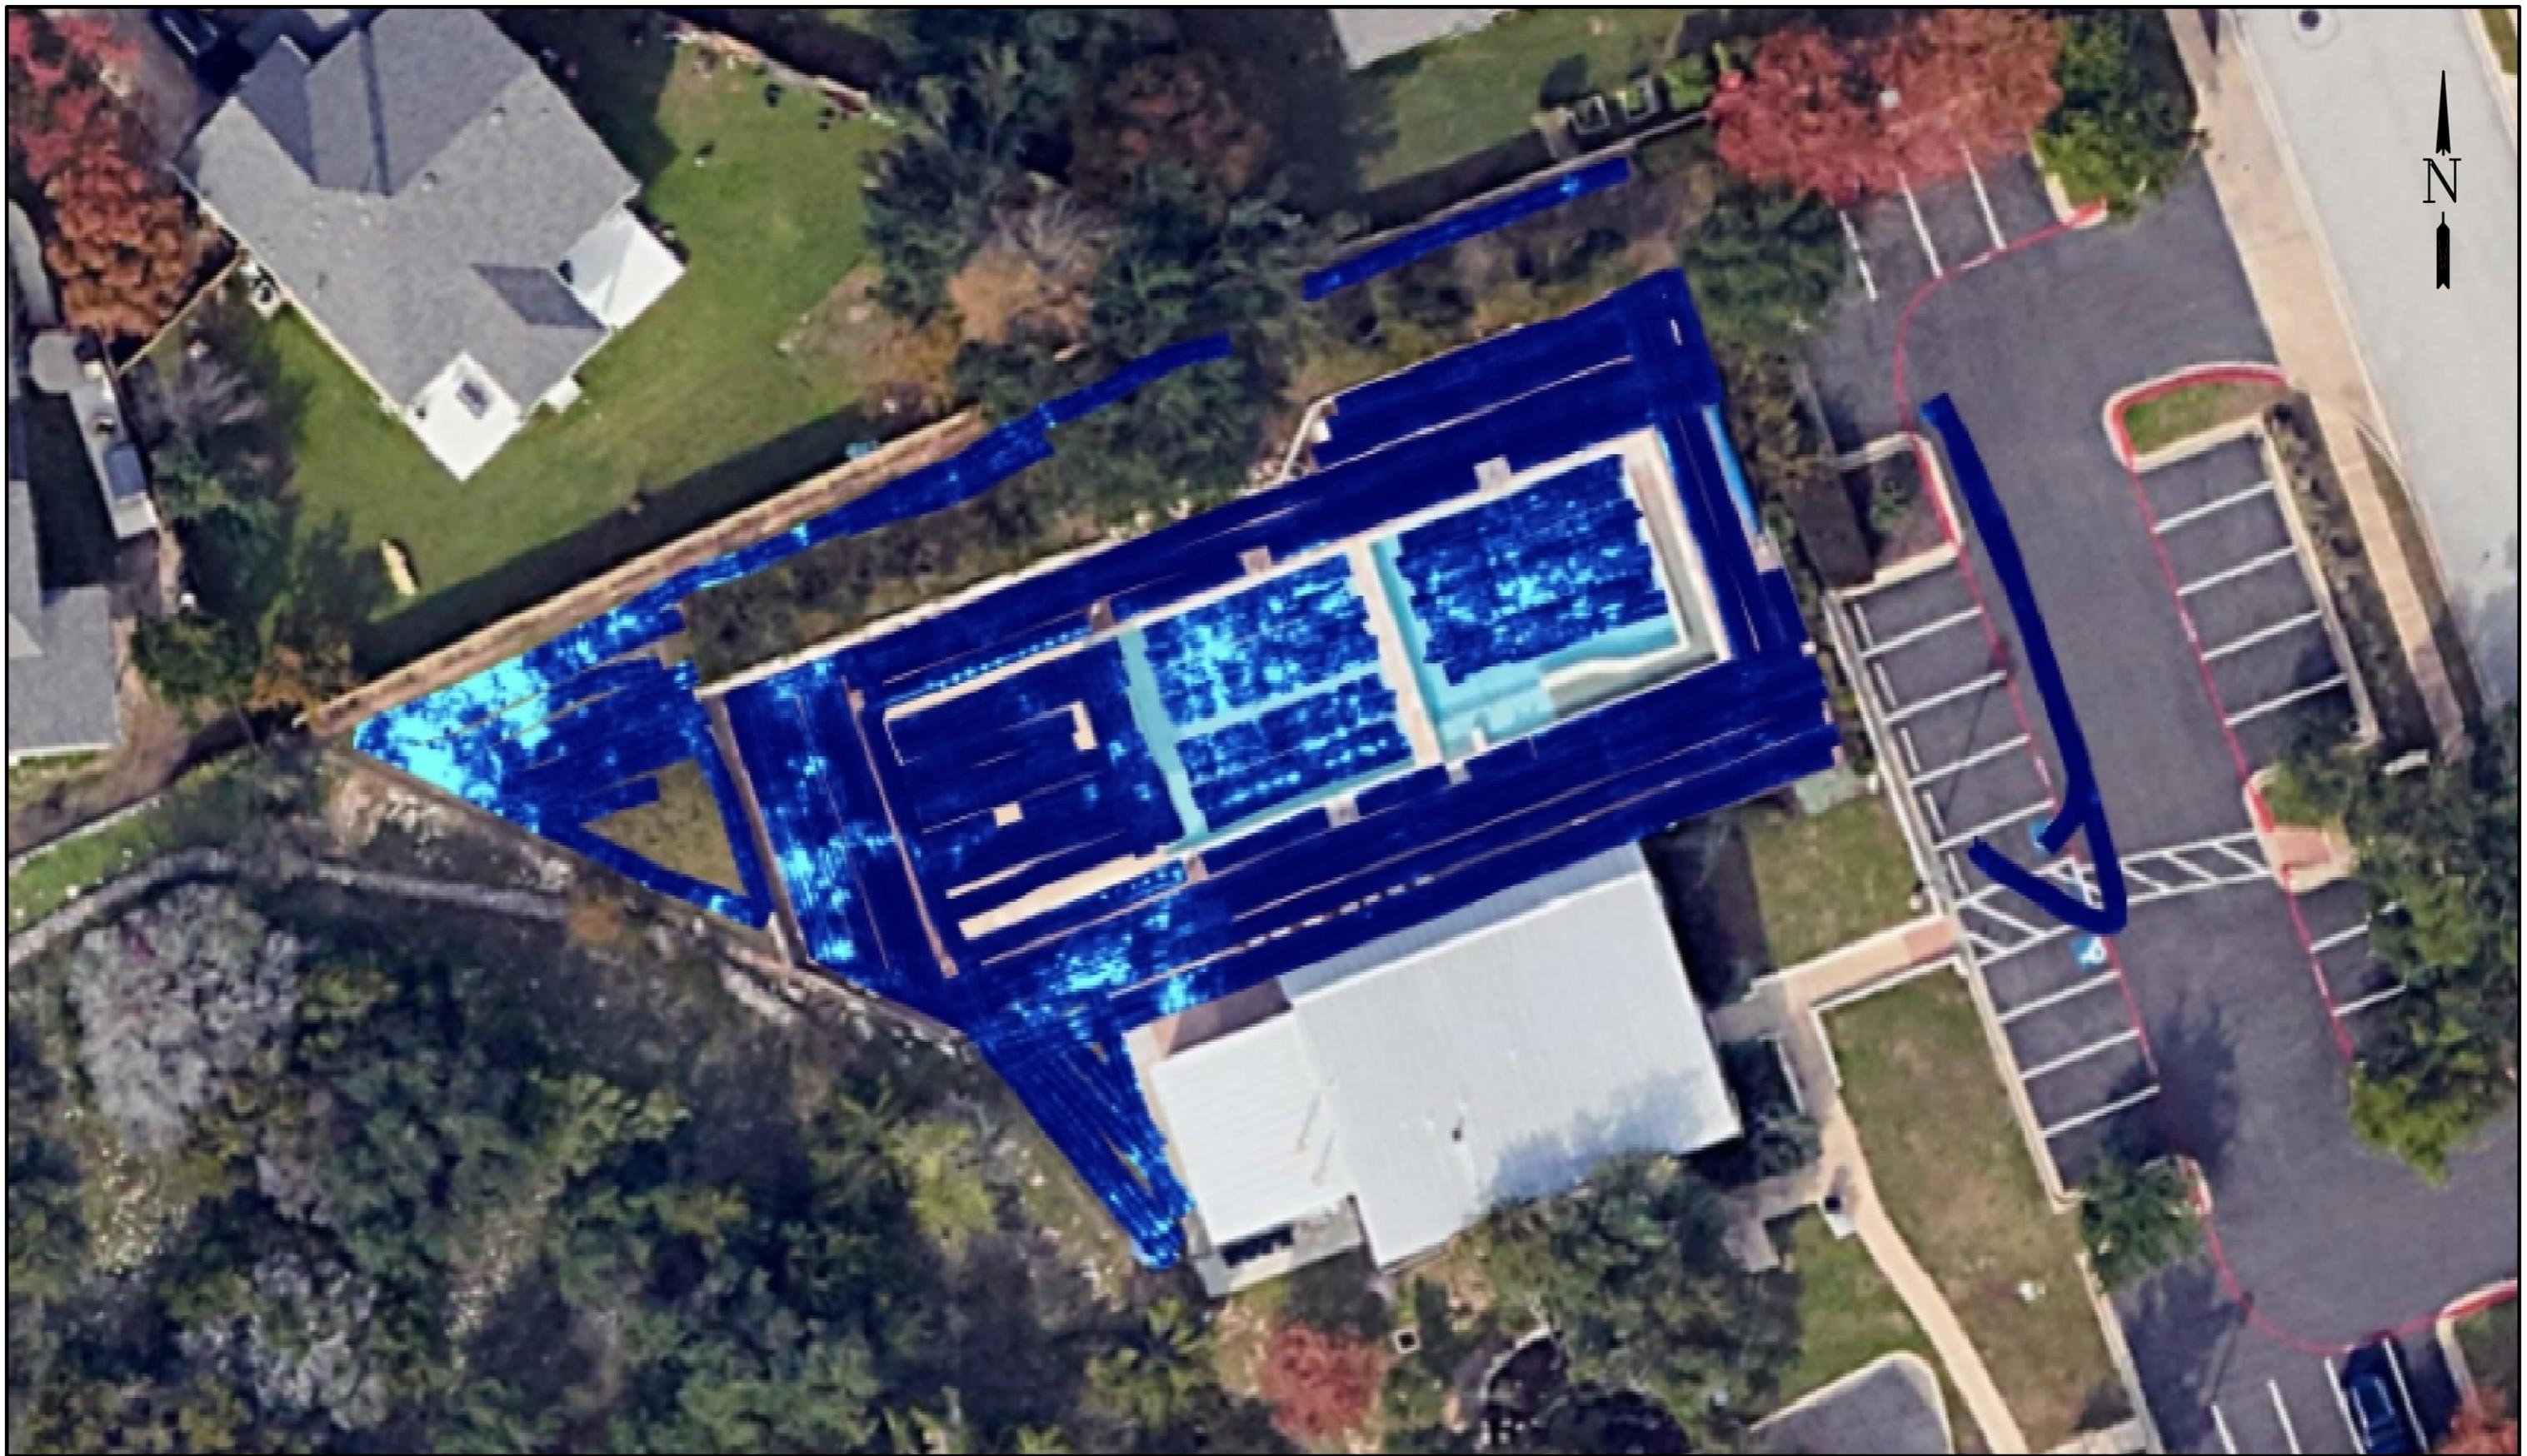
Figure No.
 9

GPR - 6ft. Depth Slice
 Highland Horizon Pool
 Austin, Texas 78717
 Project #: 26-10-006
 Survey Date: February 3-4, 2026

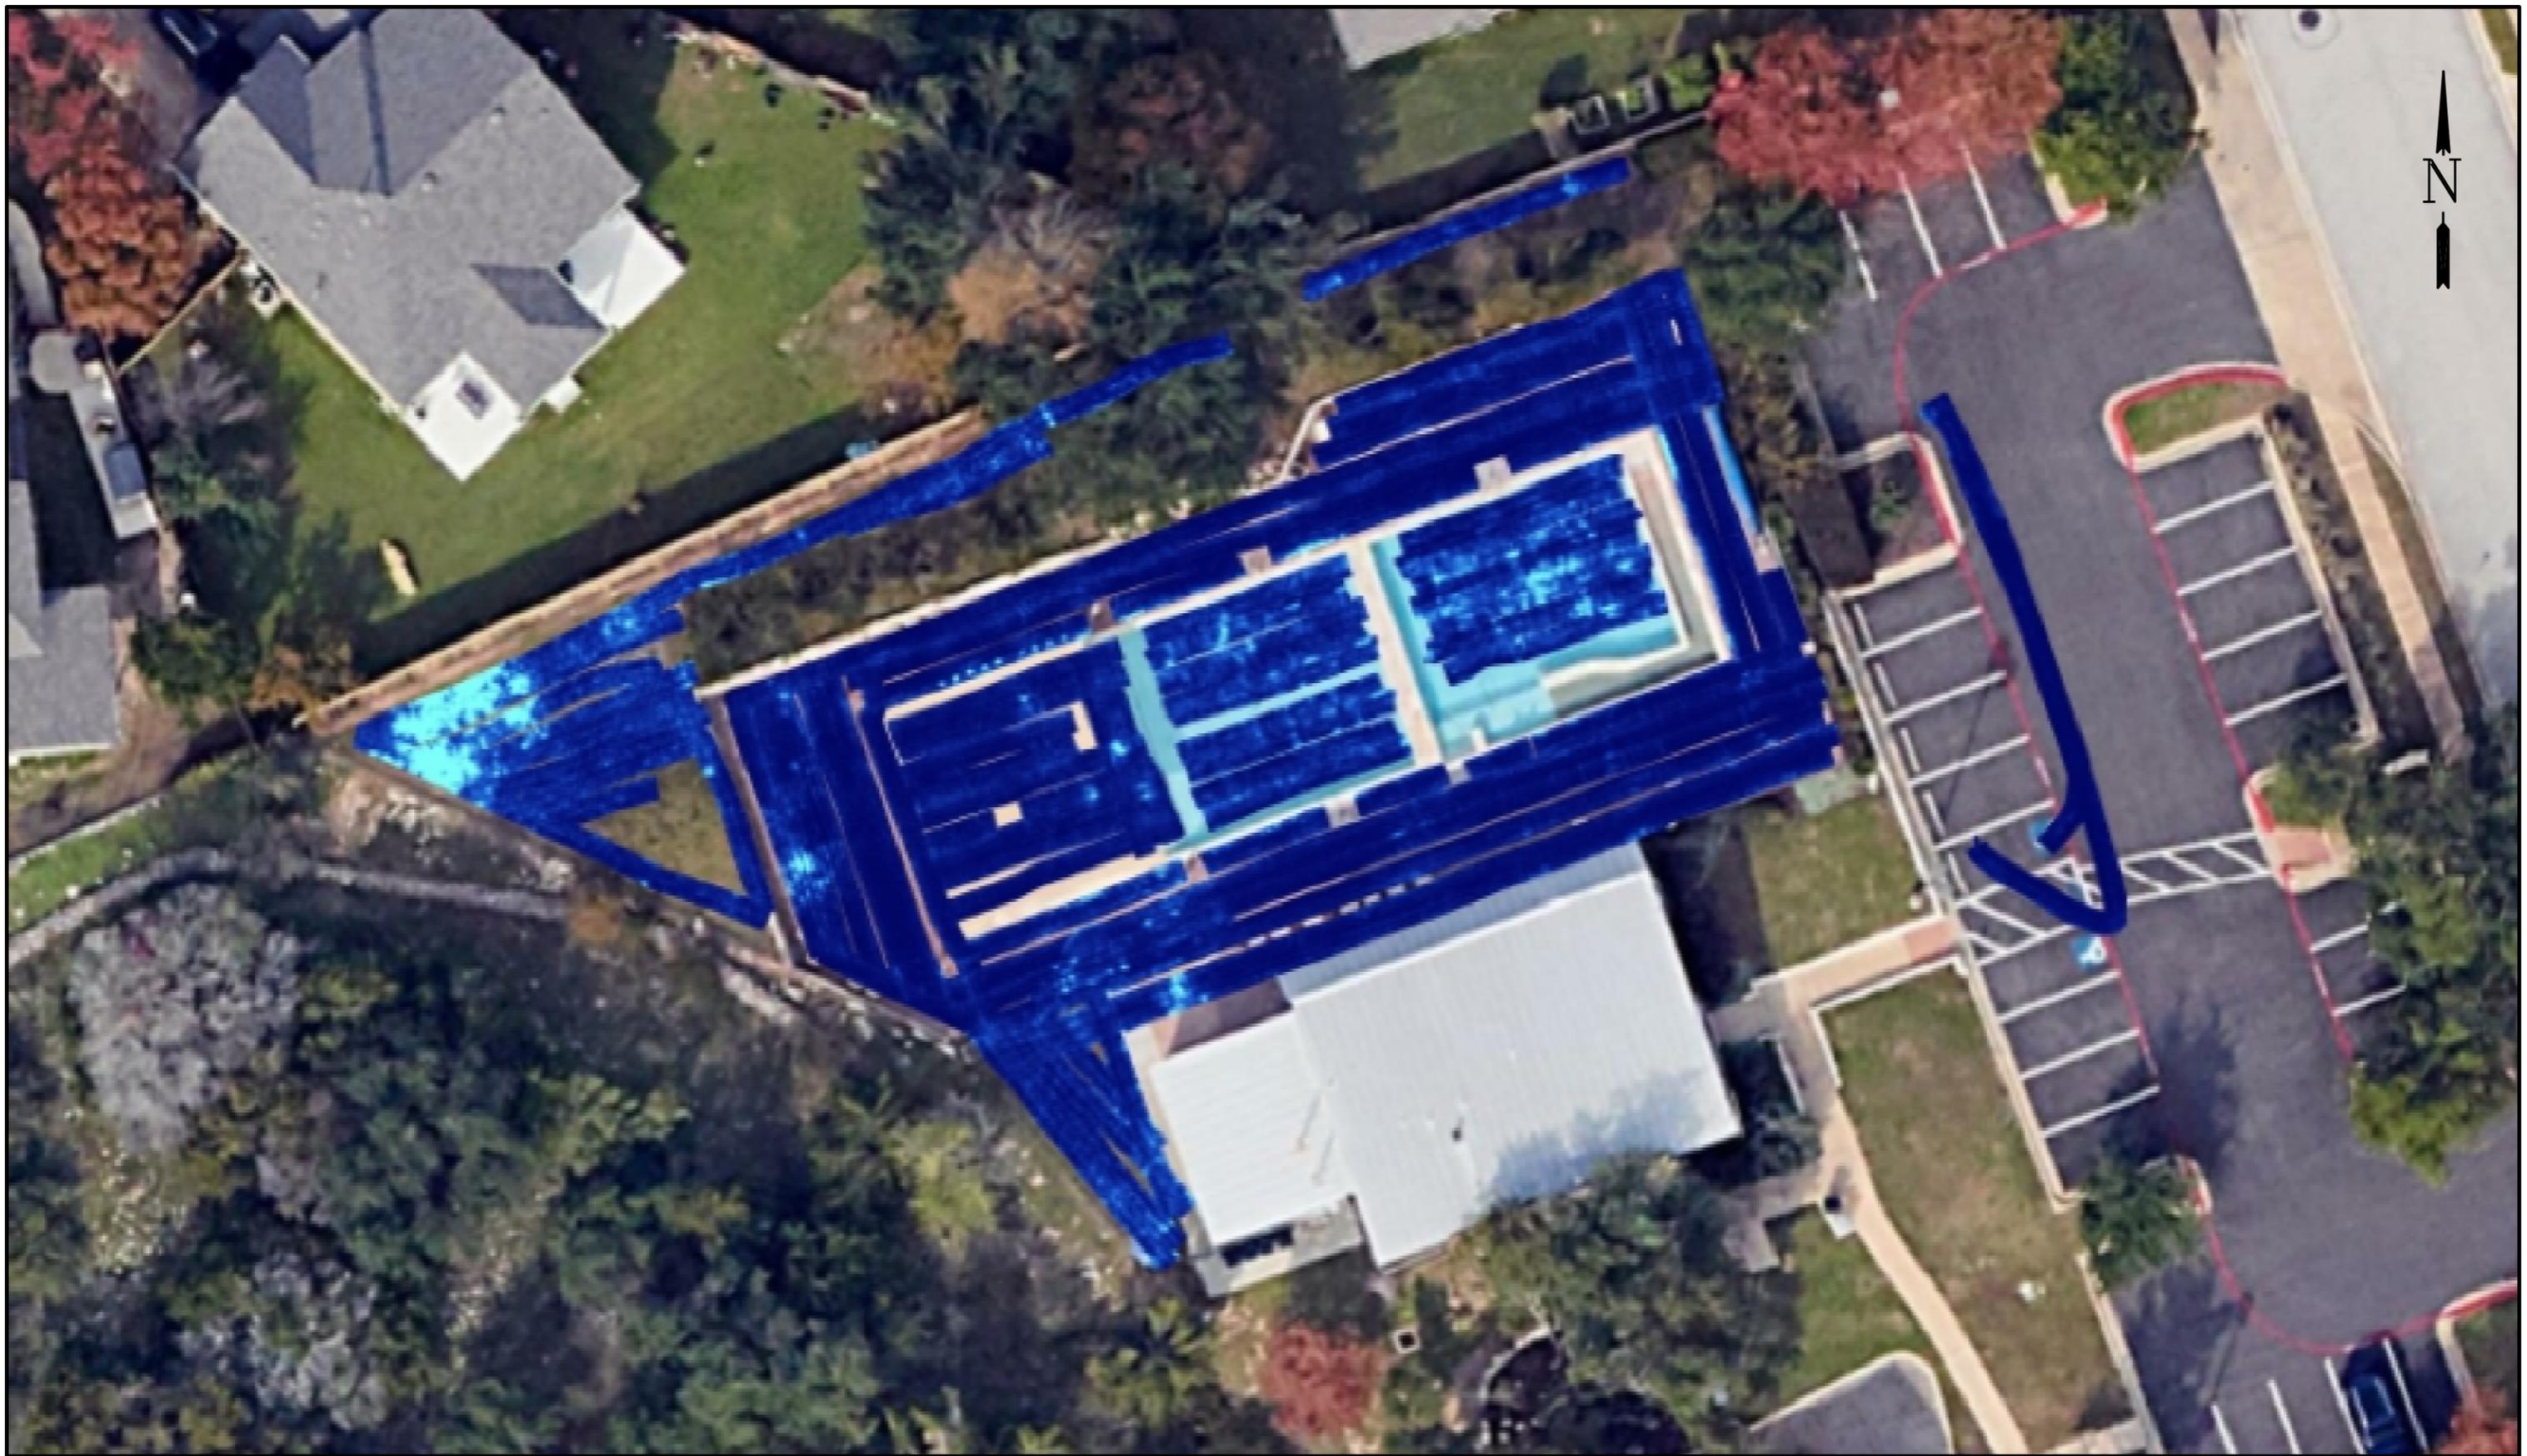
Figure No.
 10

GPR - 8ft. Depth Slice
 Highland Horizon Pool
 Austin, Texas 78717
 Project #: 26-10-006
 Survey Date: February 3-4, 2026

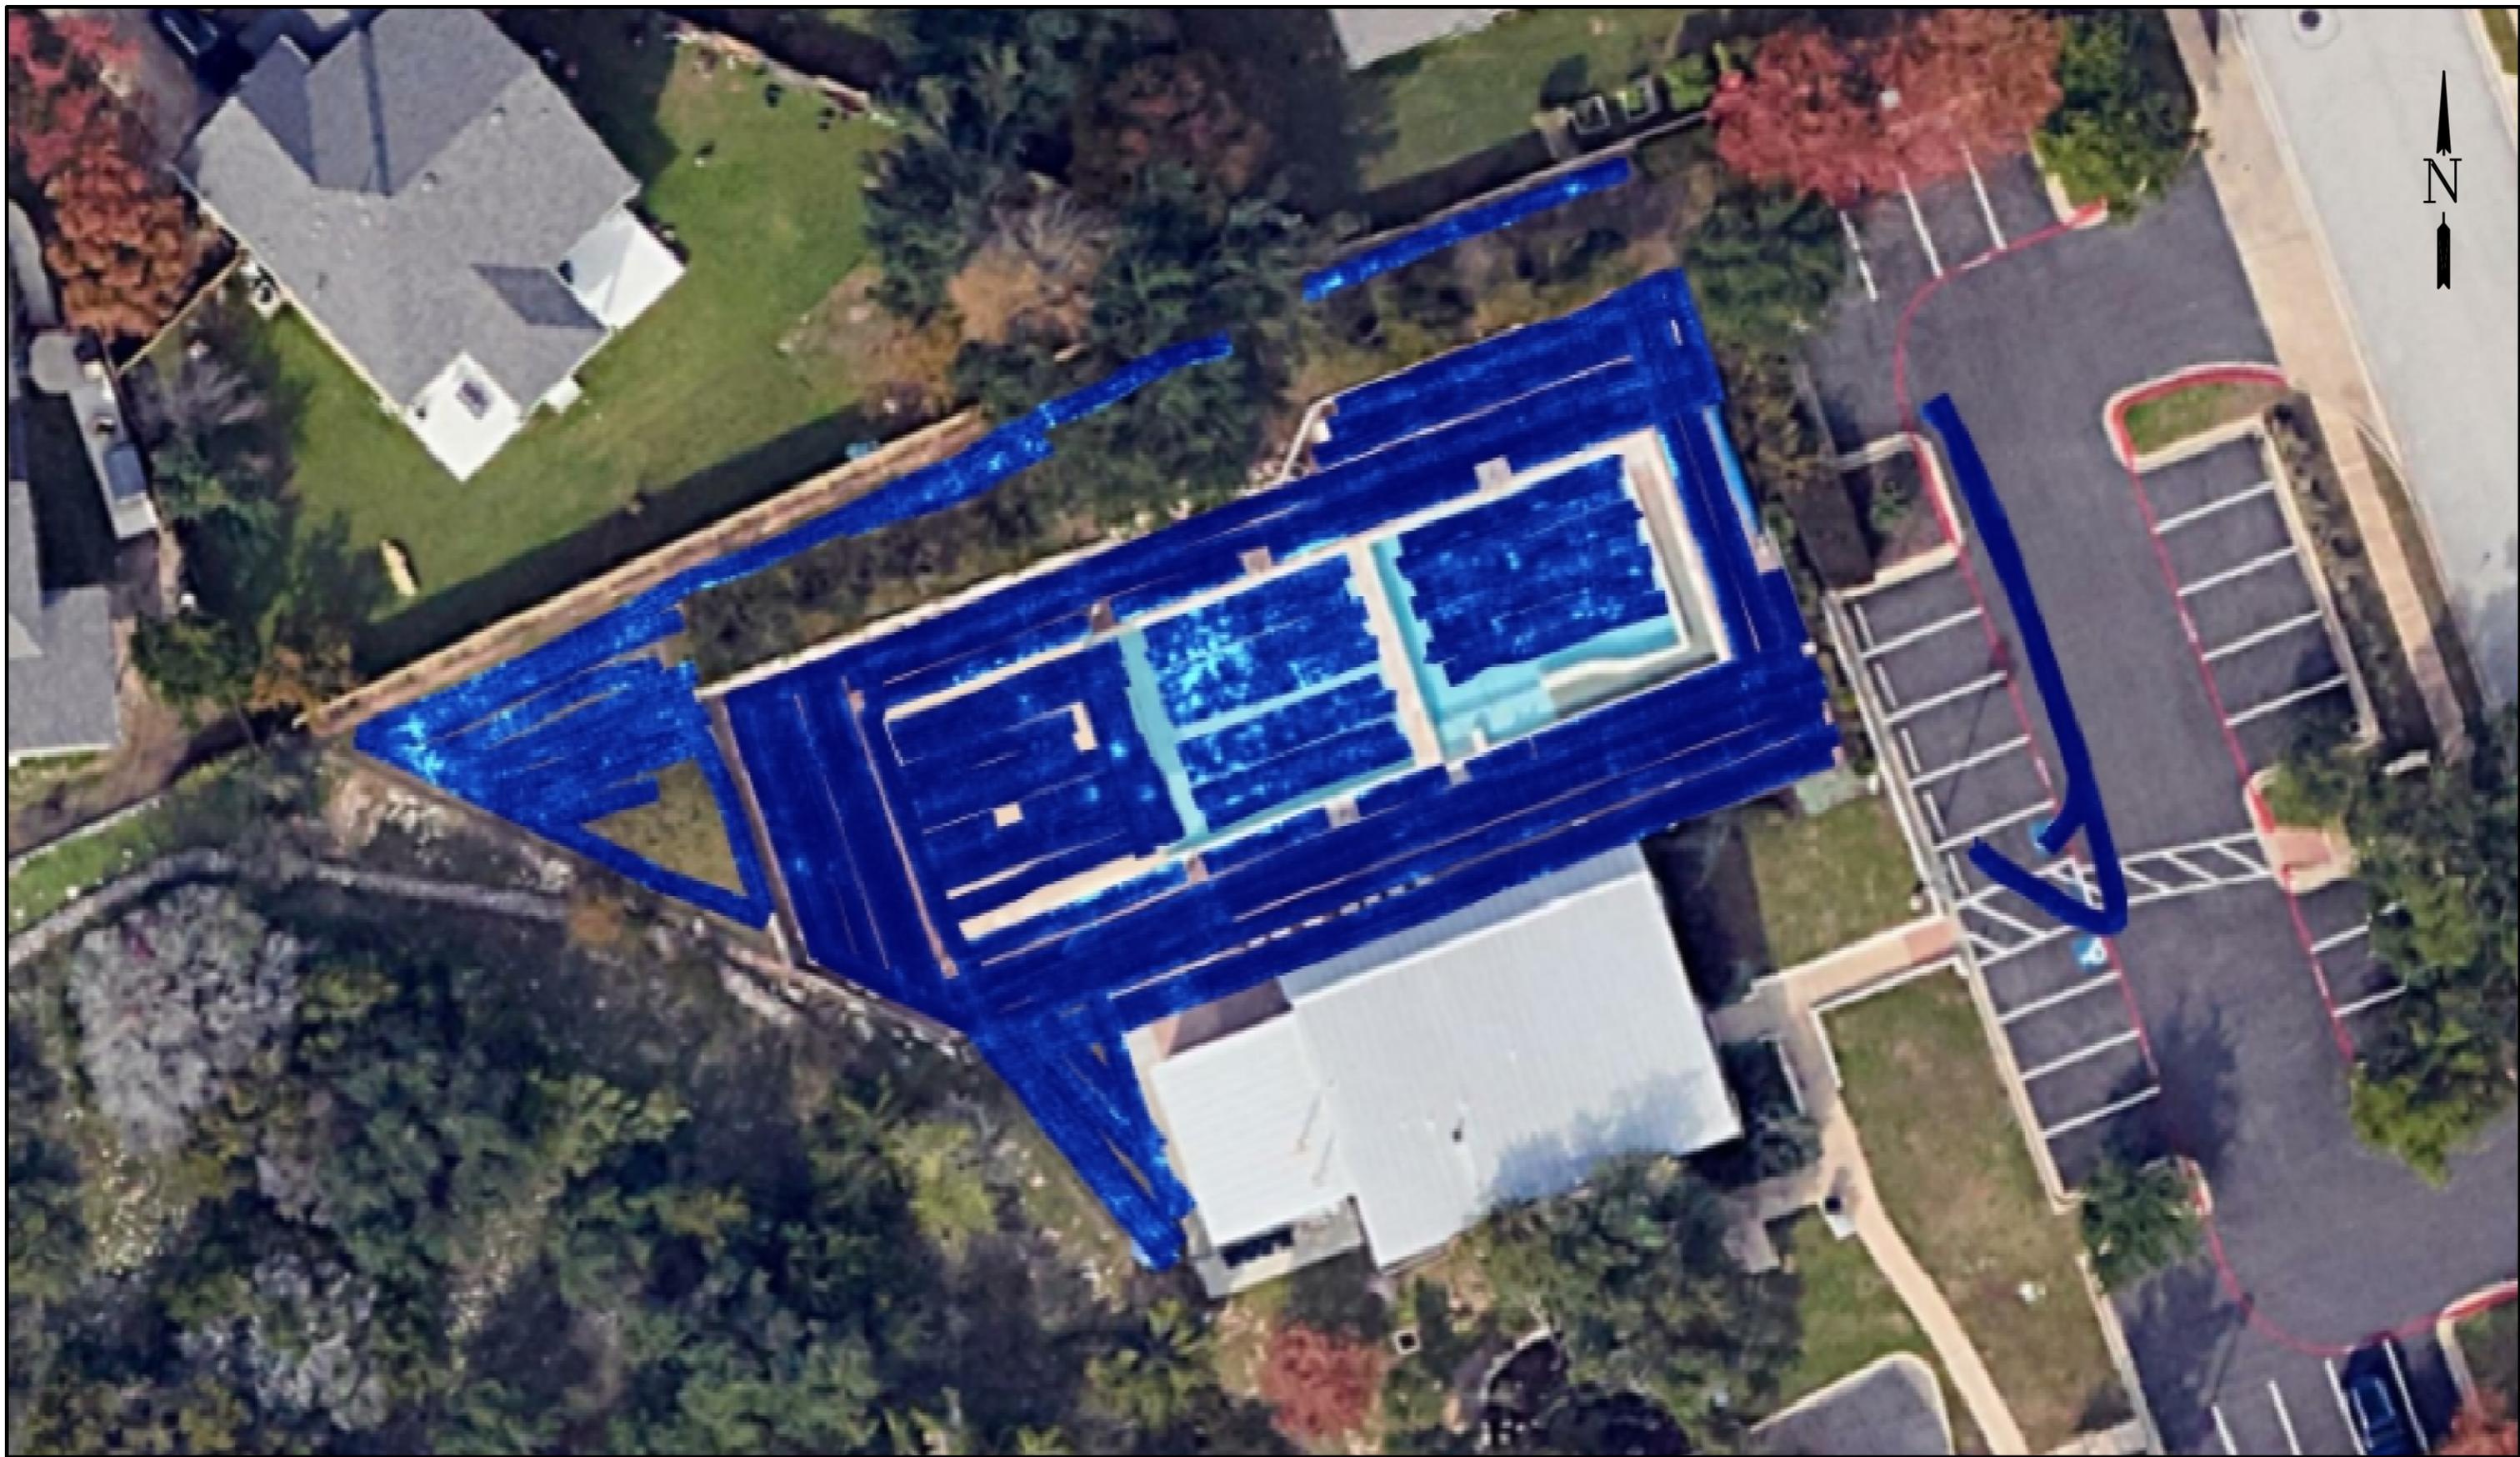
Figure No.
 11

GPR - 10ft. Depth Slice
 Highland Horizon Pool
 Austin, Texas 78717
 Project #: 26-10-006
 Survey Date: February 3-4, 2026
